INCIDENT REVIEW

3200 Mill Creek Road

A firefighter was seriously burned at a fire in a single-family dwelling

Delaware State Fire School

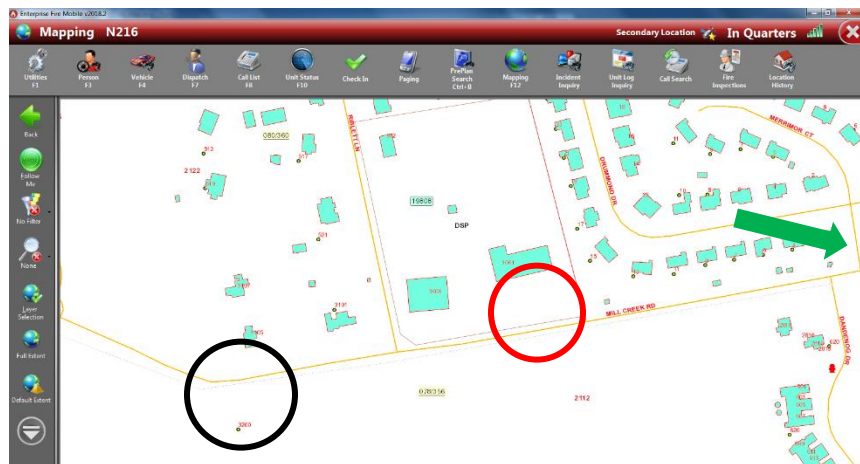
Figure 8-CAD Map (Guzzo)

19 instead of the engine they were dispatched for because they were familiar with the lack of hydrants in the area. A screenshot of the CAD map from that day shows the location of the house (black circle), a blank space where the closest hydrant was located (red circle, approximately 800 feet), and the closest known hydrant according to the CAD (green arrow, approximately 1800 feet). Several months after this incident, the hydrant in question is still not visible on the CAD.

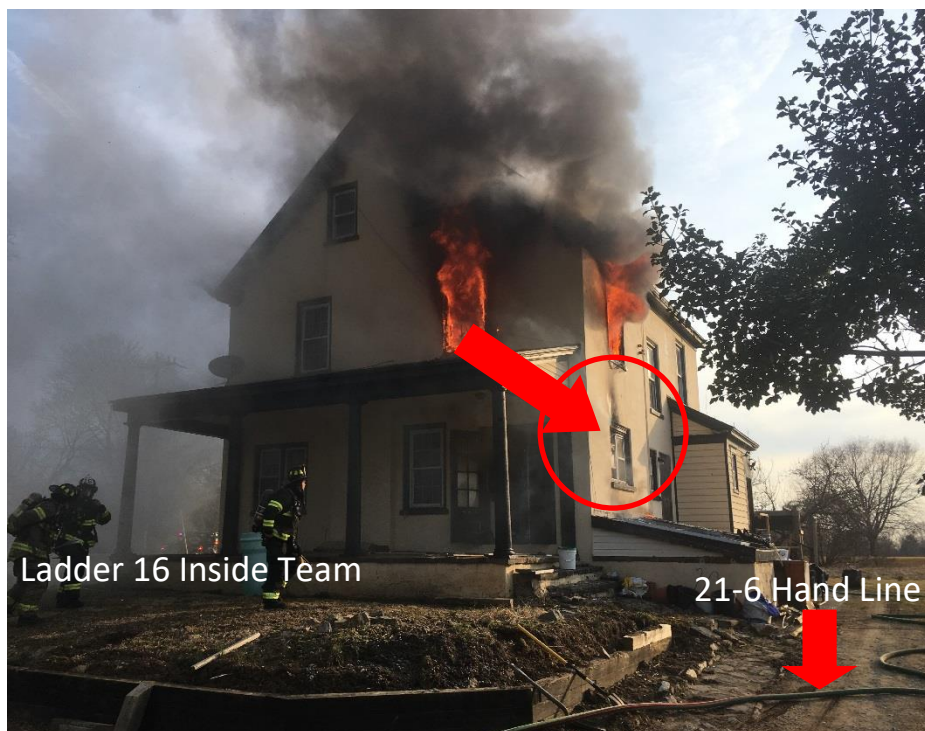
Figure 9-Laundry Room Window (Jankowski)

At no point did anyone verbally identify the fire on the first floor despite a partially failed window on the Charlie side with smoke coming from it. The county policy clearly spells out the role of the first arriving special service to perform a Charlie Side Report to include the presence of a basement, access to that basement, and if the basement is on fire.

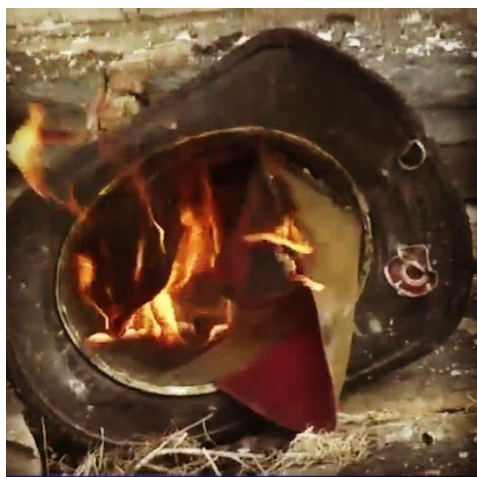
Figure 10-Helmet Burning After Mayday

Many of the firefighters on the scene were wearing helmets that do not meet current NFPA standards. Older versions of NFPA standards stated simply that if the object met the standard when it was manufactured, it remained compliant throughout its useful life. In 2008 that was changed for helmets to a 10 year life cycle (NFPA 1581, *Selection, Care and Maintenance of Structural Firefighting Protective Clothing*). The injured firefighter was wearing an old helmet (30+ years) that did not have a chin strap and the helmet fell off shortly after he fell through the floor. It did not have an impact shell. The inner lining and ear flaps were apparently made of combustible material because they burned completely away (See Appendix E).

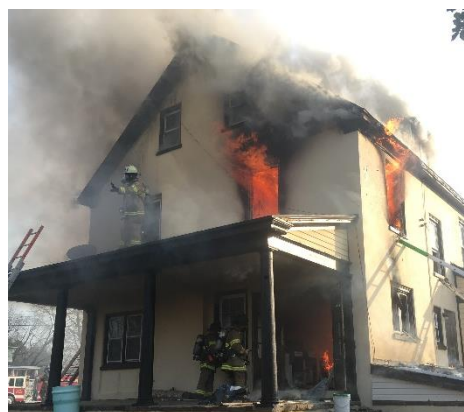
Figure 13-Uncoordinated Venting (Jankowski)

Ventilation was occurring during a known lapse in water application. The video shows windows being taken in rooms unrelated to the fire while no water was available.

One firefighter stated that he broke a window distal to the fire room “to draw the fire” away from the mayday. This became the only other room on the second floor damaged by fire. Training needs to be provided on fire behavior and how to coordinate ventilation with fire attack.

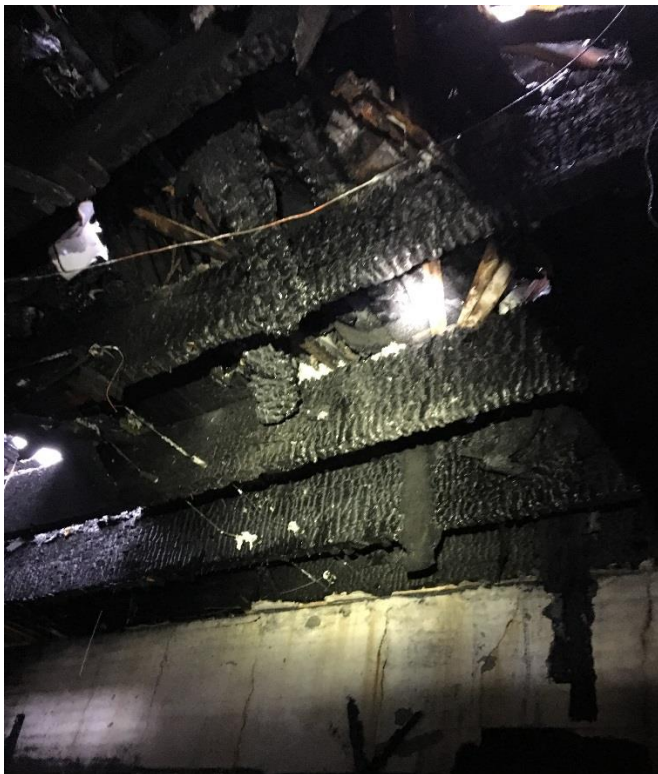
Figure 27-Void Between Laundry Room & Bedroom (Dempsey)

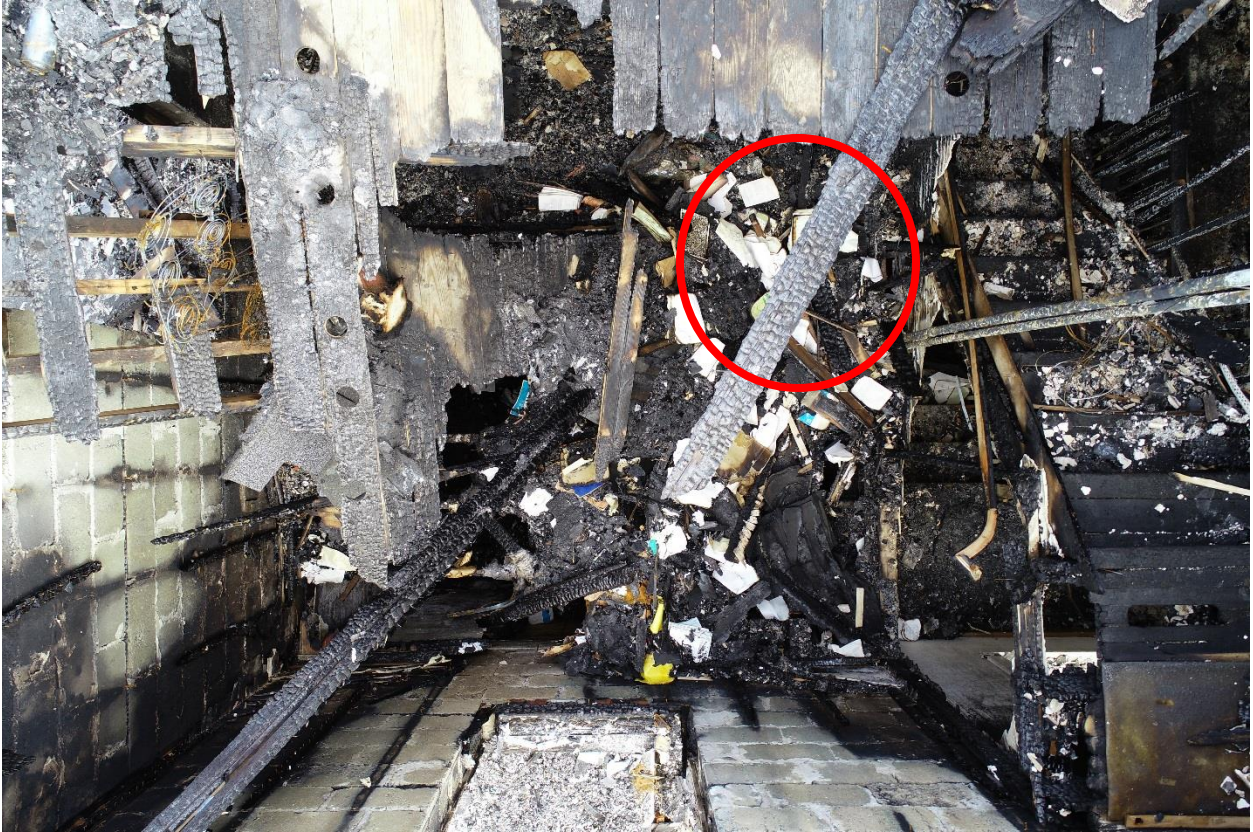
Figure 28-Approximate Location of Where Smiley Fell Through the Floor (Dempsey)

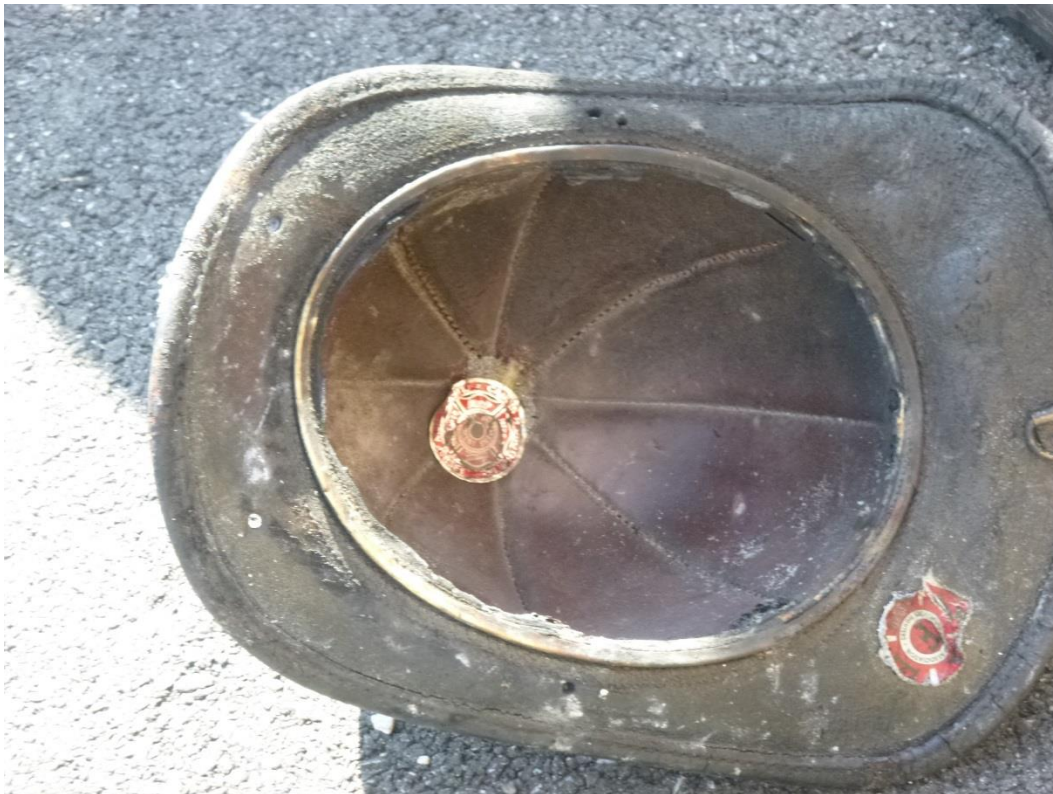
Figure 34-Interior of Helmet, Ear Flaps and Liner Had Burned Away
